SALVAGE FISHERMAN'S MUSEUM

2021 BUILDING RENOVATIONS REPORT

Prepared by Maryssa Barras

Published Aug. 19, 2021

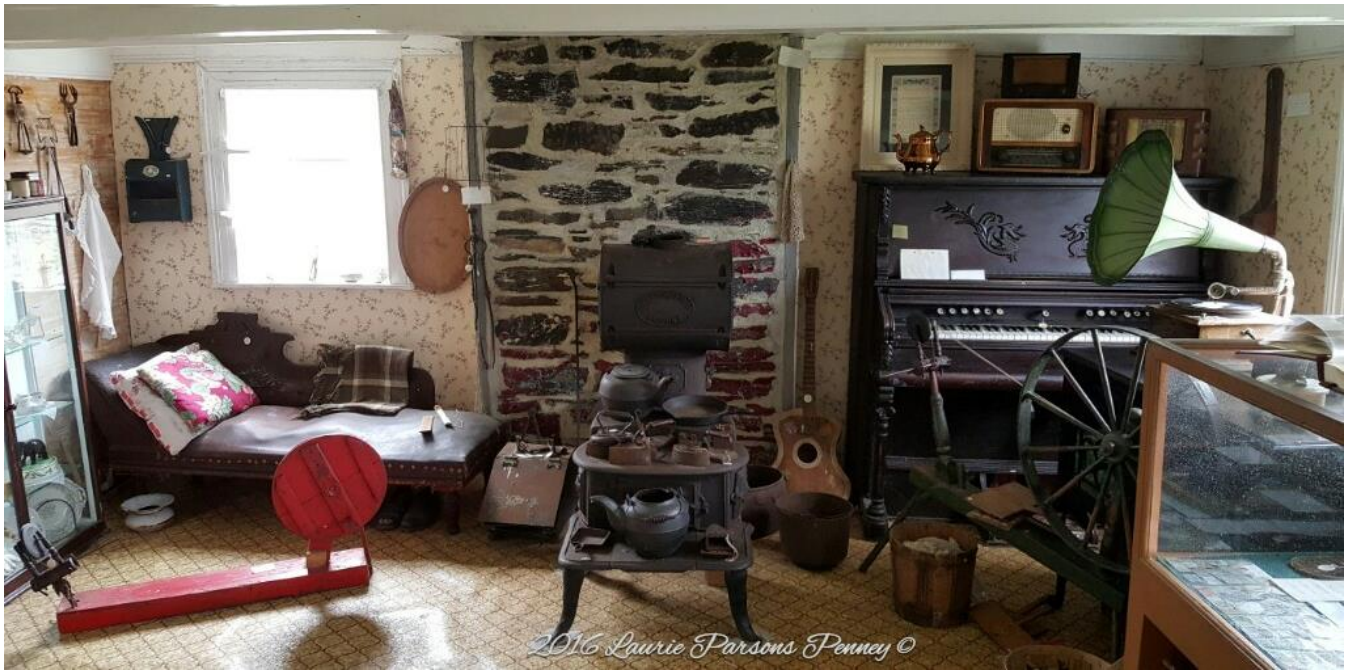
Image 7 (Top): First story interior of the museum. (Laurie Parsons Penney, 2016)

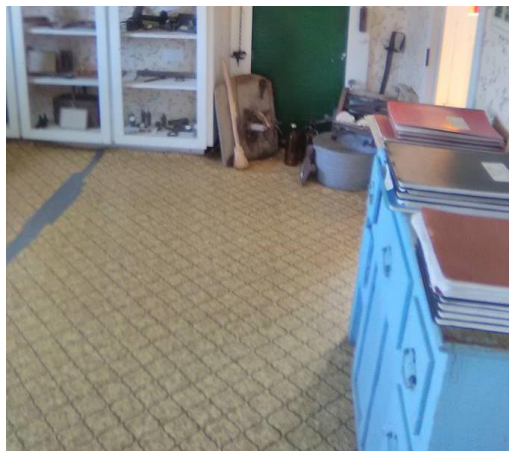
Image 8 (Left): First story interior of the museum (Bill Barbour, 2020)

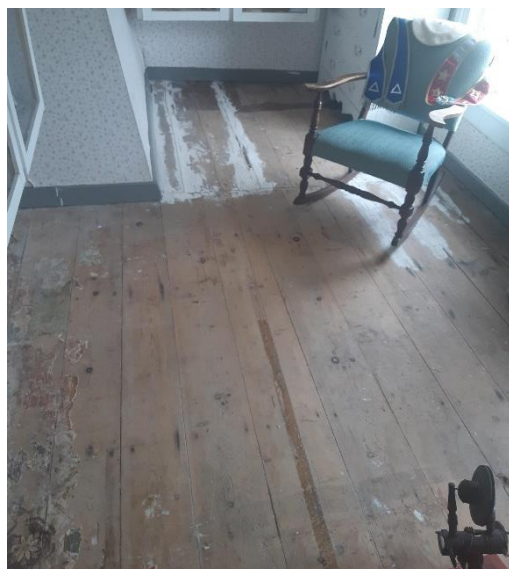
Image 9 (Bottom Left): Second story interior of the museum (Bill Barbour, 2020)

The only area of concern identified in the interior of the building was the flooring on the first level, which was uneven and sunken in in different places. The flooring material on the first level was poor-quality linoleum flooring which has been improperly installed, and which was lifting in certain areas giving the floor a 'squishy,' or 'bubbly' feeling. While not structurally critical, this flooring is not authentic to the building's heritage value and was identified as a safety and tripping hazard. All of the structural issues with the floor were noted to be caused by the foundation below it.

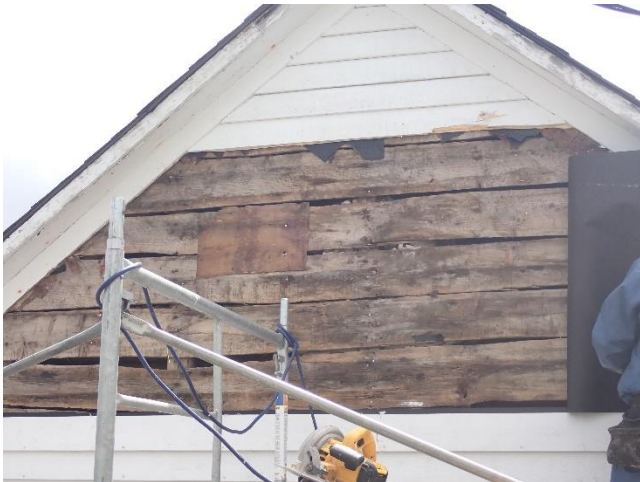
Image 28 (Bottom Left): Image of the west gable end of the building showing a piece of birch bark (Photo by Maryssa Barras, 2021)

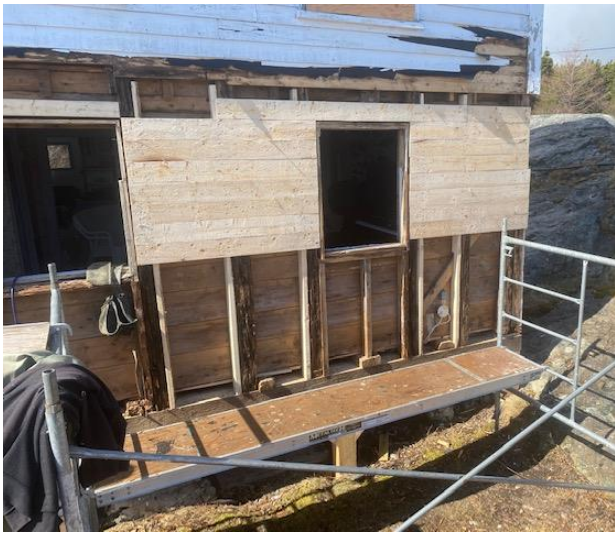
Image 30 (Top left): View of front façade being sheeted (Barbour Services Inc, 2021)

Of all four sides, the front of the building was in the worst state. The vast majority of sheathing on this side of the building needed to be replaced. Underneath sheathing the studs on the front of the building suffered from a great deal of surface rot, although the studs themselves were still in great overall condition. Original studs were all preserved, and sister studs were added where needed for additional structural support.

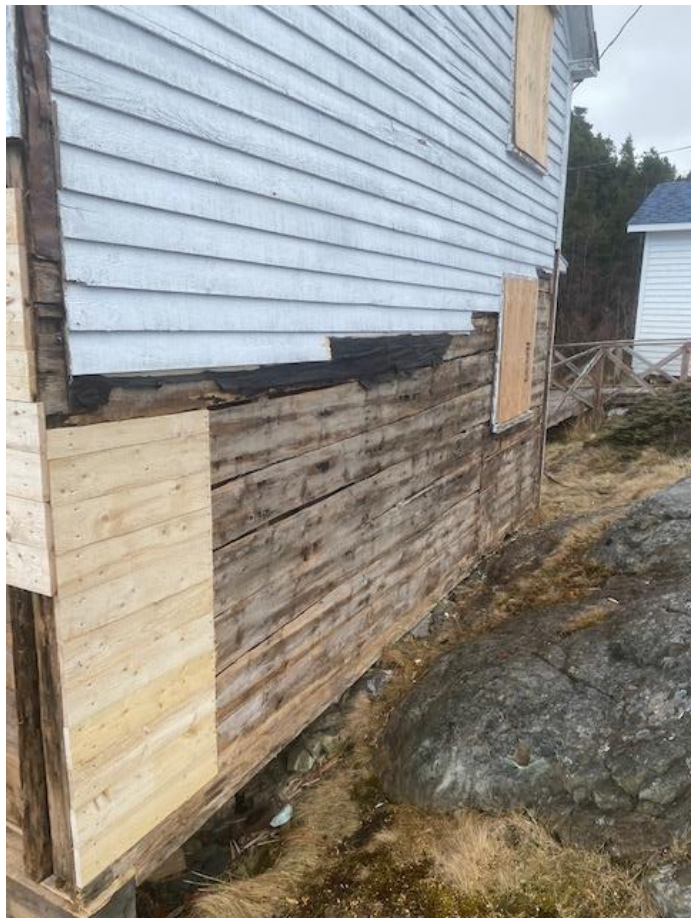
Image 31 (Bottom left): View of the intact sheeting on the east gable end of the building (Photo Barbour Services Inc, 2021)

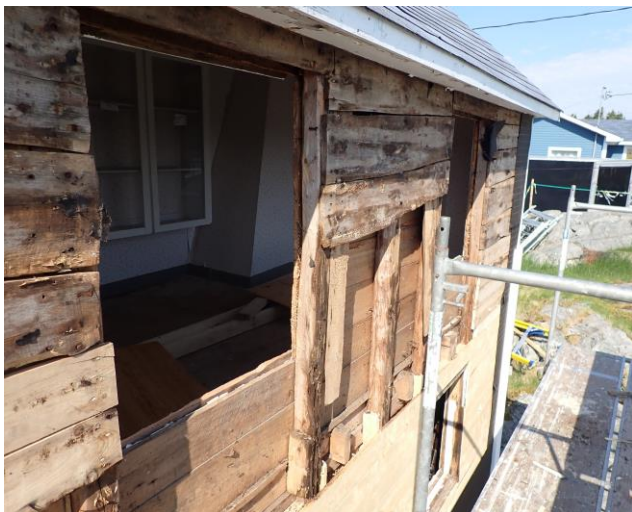
Image 34 (Left): Exterior view while windows were removed for restoration (Barbour Services Inc, 2021)

Windows were removed prior to any major work on the building and restored off site. The majority of window boxes across the building needed to be completely replaced as a result of extensive rot. Even in the least affected areas, rot had warped and degraded the wood to such a degree that it would be impossible to create a watertight seal. Where possible, elements of the older window framing was preserved. In total, only one window was preserved in its entirety (minus the exterior window box).

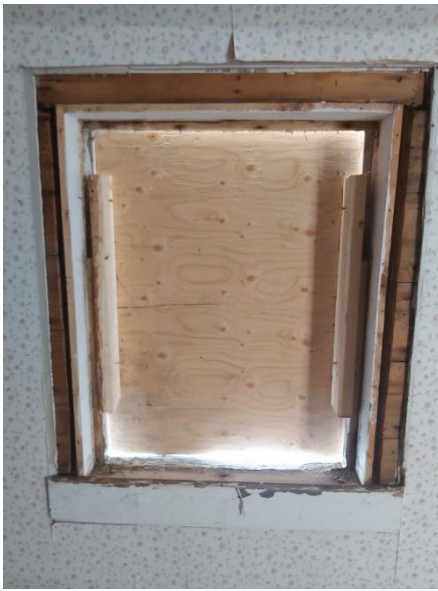
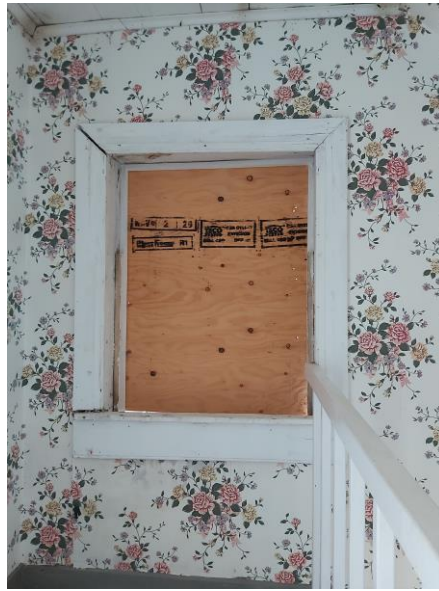
Image 36 and 37 (Top left and middle): Interior view of window boxes during restoration (Photo by Maryssa Barras, 2021)

Offsite, window units were repaired and restored by first scrapping and cleaning any areas of concern, then filling in gaps with wood putty to tighten loose frames. Once the frames were restored they were painted with three coats of linseed oil paint with added zinc. This paint had an unusually long drying time, taking nearly a week between coats to properly dry. As a result, some of the paint on the window frames is 'drippy' and uneven, and some of the new frames were painted with their final coats after installation. While imperfect, this uneven paint job is more authentic to the original aesthetic of the windows than perfectly even coats.

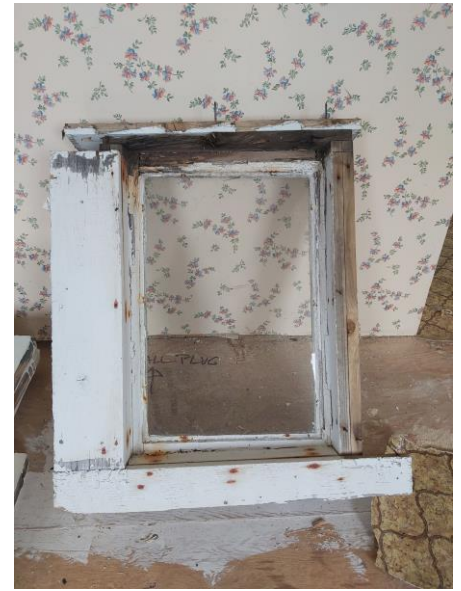
Image 38 (Top right): Removed top attic window, still in its frame (Photo by Maryssa Barras 2021)

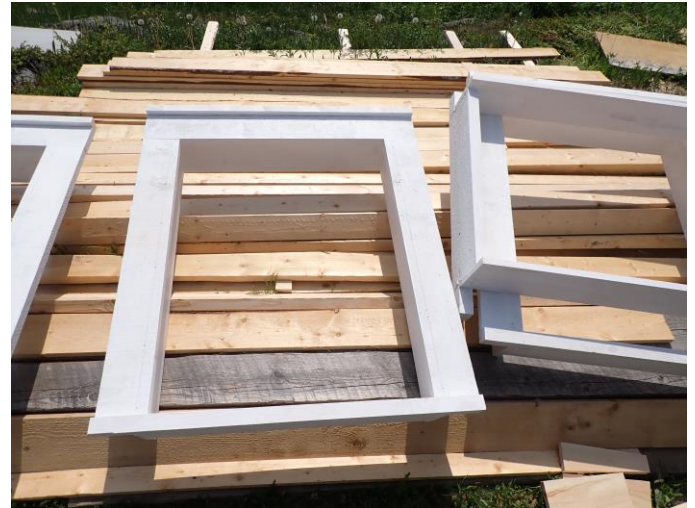
Image 40 (Middle right): Newly constructed window boxes prior to being installed (Photo by Maryssa Barras 2021)

All exterior window boxes were not salvageable and had to be reconstructed. The exterior boxes were installed prior to clapboard over tar paper for a watertight seal, but the interior frames and windows were not reinstalled until after the clapboard was completely replaced. The exterior boxes were also caulked both before and after windows were installed, with a lower sill angled at a standard 10° to prevent water pooling.

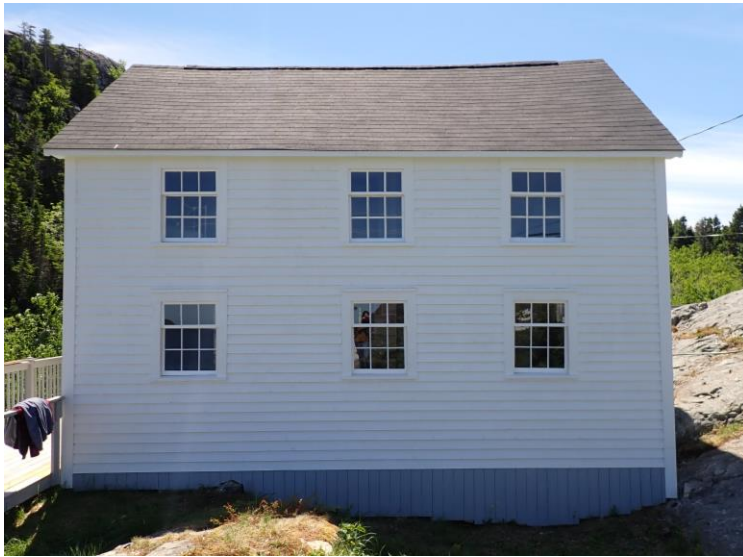
Image 42 (Top): View of front façade with windows installed (Photo by Maryssa Barras, 2021)

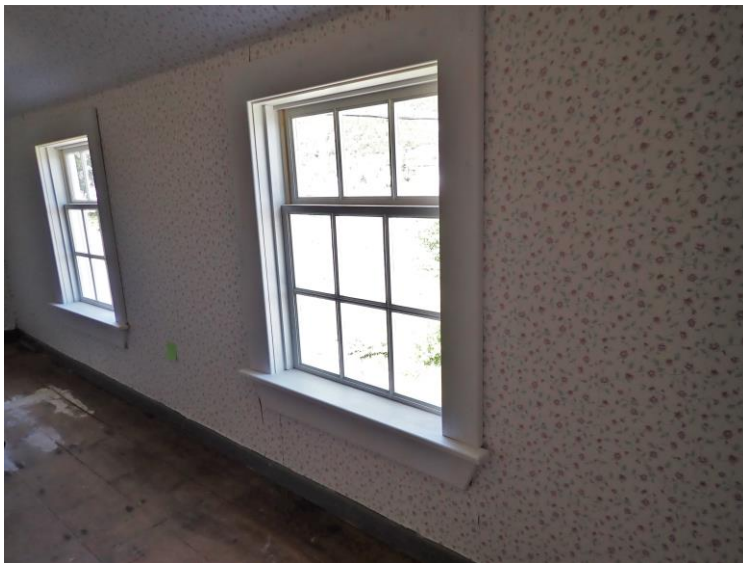
Image 43 (Middle, above): Interior view of installed windows (Photo by Maryssa Barras, 2021)

While nearly all of the original windows contained historic glass, this glass needed to be removed in order to properly restore and re-seal the window frames from leaks. While the historic glass was in excellent condition prior to restorations, they were made from a particularly brittle material prone to breaking. Unfortunately, the caulking previously used to seal the windows was tough and needed to be scraped off of the fragile glass with a fair bit of force. Between the removal and scraping processes, all of the original window glass was, regrettably, destroyed or cracked. As a result, all new glazing needed to be installed in the restored frames. Glazing was sealed in the restored frames using #33 putty.

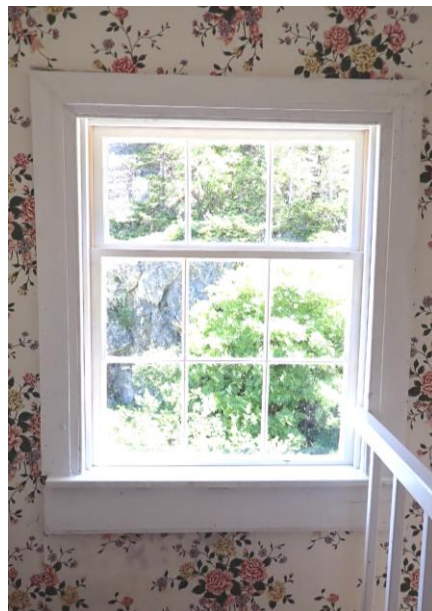
Image 44 (Right): Close up image of the second story west gable end window – the only window completely restored without replacing components – post restoration (Photo by Maryssa Barras, 2021)

Despite being offset to open, prior to restorations all of the windows were so warped and swollen that none of them could open easily – if at all. The linseed oil paint used on the original windows had also fused different components together over time, making it impossible to open most windows without damaging the paint. In order to make the museum's windows more functional the interior components of the window jamb were left unpainted so that the windows would be able to open more easily.

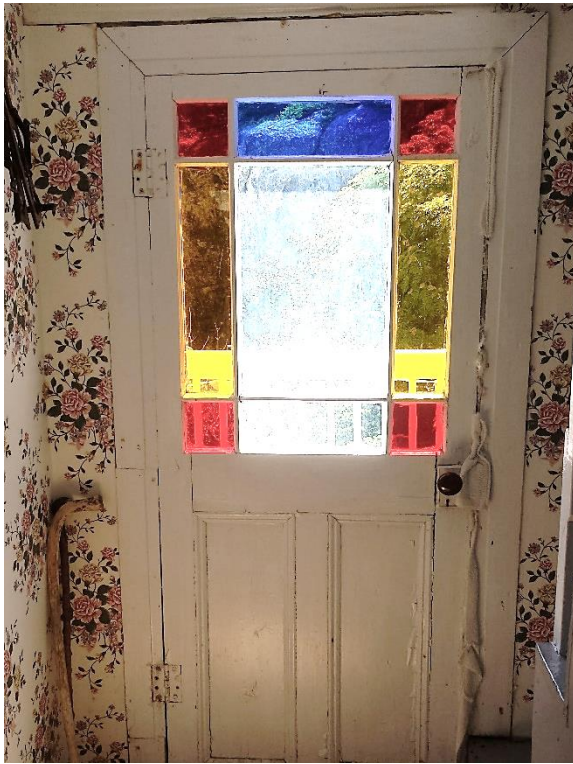
Similarly to the window frames the front door frame for the building was rotten beyond repair and needed to be replaced. This is not surprising given that the door had been notoriously leaky prior to renovations, and had been sealed with rags for years. Restorations to the door were completed offsite, and four pieces of the original coloured glass were saved. Three pieces of coloured glass, the top blue panel and two square orange corner panels, shattered during restorations. Barbour Services technicians initially installed clear glass to replace the panels which had broken. Given that the coloured glass was an important characteristic component of the building the SFMC felt it was integral to ensure that coloured glass was re-installed in the door. The door was therefore re-glazed with correctly coloured glass and re-installed at a later date.

Image 45 (Top): Image of the stained glass door (Photo by Nancy Murphy, 2020)
